County of Frontenac Energy Assessment

As Per: O. Reg. 507/18 Energy Conservation and Demand Management Plan

June 2019

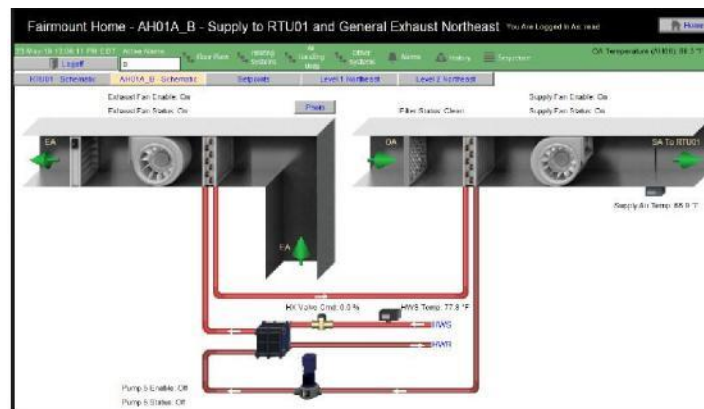
Study of one RTU and the associated graphic in the Building Automation System (BAS) raised the possibility that a design or installation error has created an arrangement where heated boiler water is flowing through a coil in the exhaust air stream, needlessly heating this air before it is exhausted. The graphic from the BAS is reproduced below:

Even if the flow direction in the red glycol pipe was reversed, it is almost impossible that the temperature of the water in the exhaust coil would be lower than the outgoing air (70F). If the water is warmer than the air flowing through the coil, heat is being lost.

An isolated glycol loop with an exhaust coil and an intake coil could transfer heat effectively between exhaust and intake air if it was not connected to boiler water. The intake coil would pre-heat incoming outside air, but then a second coil with boiler water would be needed to finish the heating. On inspection, only one heating coil was found on the intake side of the RTU.

It is recommended that further study of the actual installation be undertaken. If the exhaust coil is warmer than 70F when the boiler is operating, the system can be confirmed to be incorrectly configured and needlessly dumping heat.

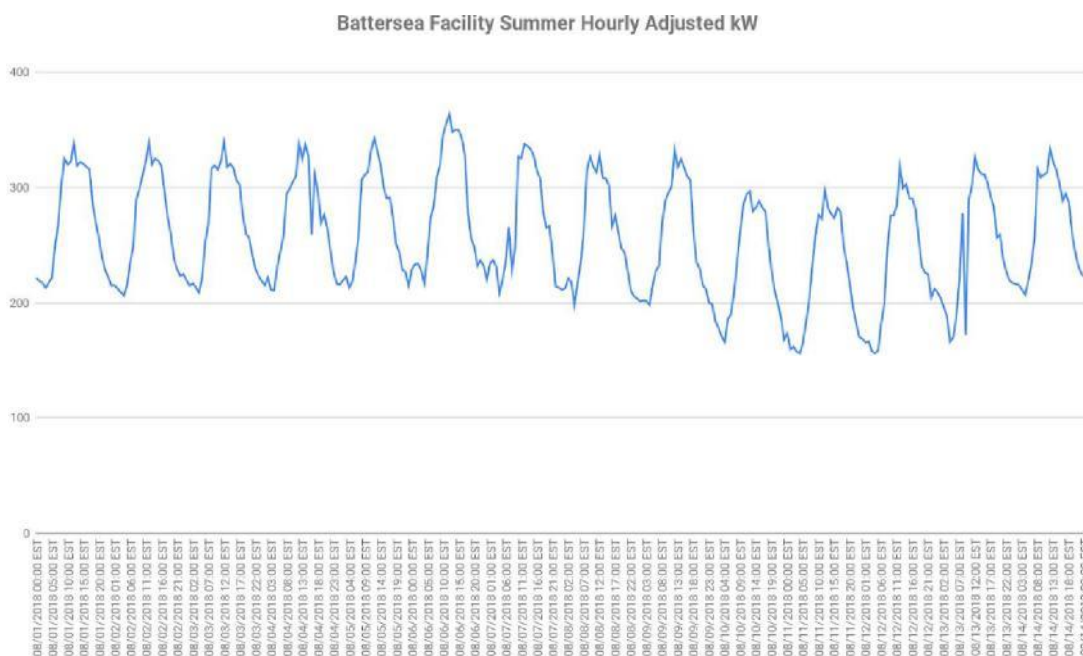
The graphic above shows a sample two-week period in summer for Battersea Road. The peak for each day is obvious, but it can be seen that one is noticeably higher than the others. If this were a month, that high peak would trigger the demand charge for the whole month. Demand charges are about 30% of the overall electricity bill for this facility, so reducing monthly peak demand can have a strong payback.

As discussed in the utility bill section, Fairmount currently pays \$19.44 for every kW of peak demand every month. Reducing these peaks by just 10 kW would save \$2300/yr. Another way to think about this is to consider a 1500 W coffee maker unnecessarily left on during a peak electrical cost period almost \$30 for that month. An effective demand management strategy involves carefully logging when peaks occur (hourly data is available for download from Hydro One) and discovering all the loads that were on during the peak. In anticipation of a peak, any non-essential loads would be switched off for a short time by a control system. Such loads might include refrigerated vending machines, domestic refrigerators, or even walk-in coolers if a slight temperature rise could be tolerated.

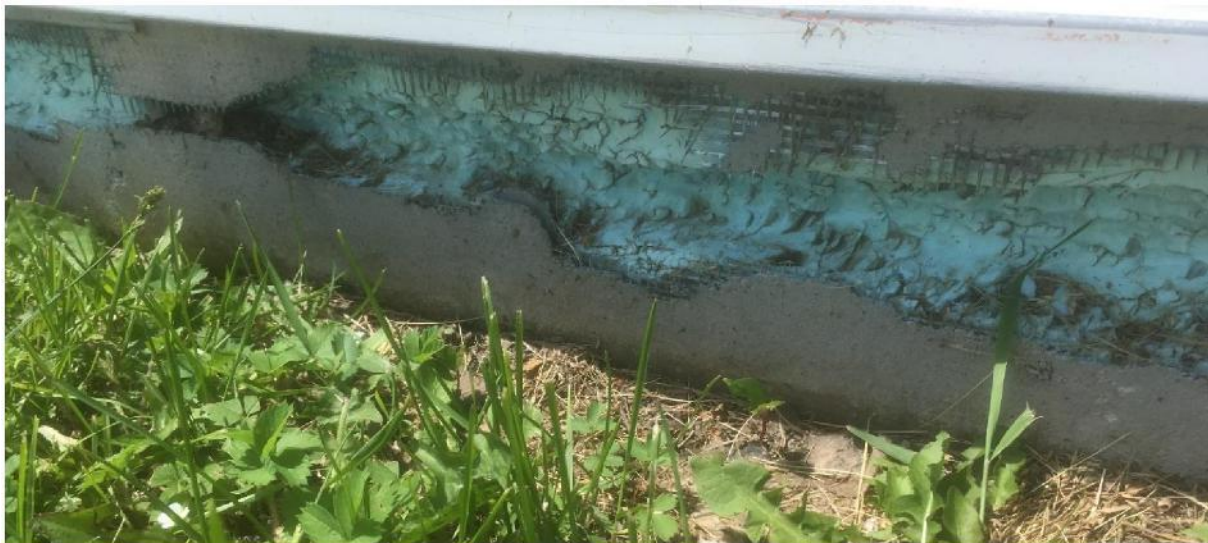
The foundation insulation was found to be damaged on the exterior of the building, likely from the use of a weed trimmer:

The building has insulated frame walls, but the foundation wall is uninsulated and partially exposed above grade. The savings above are estimated based on adding R-value 15 to the wall, which can be done using rigid XPS foam or sprayed two-component polyurethane. A fire rated coating can be sprayed on top of the foam, eliminating the need for a frame wall.

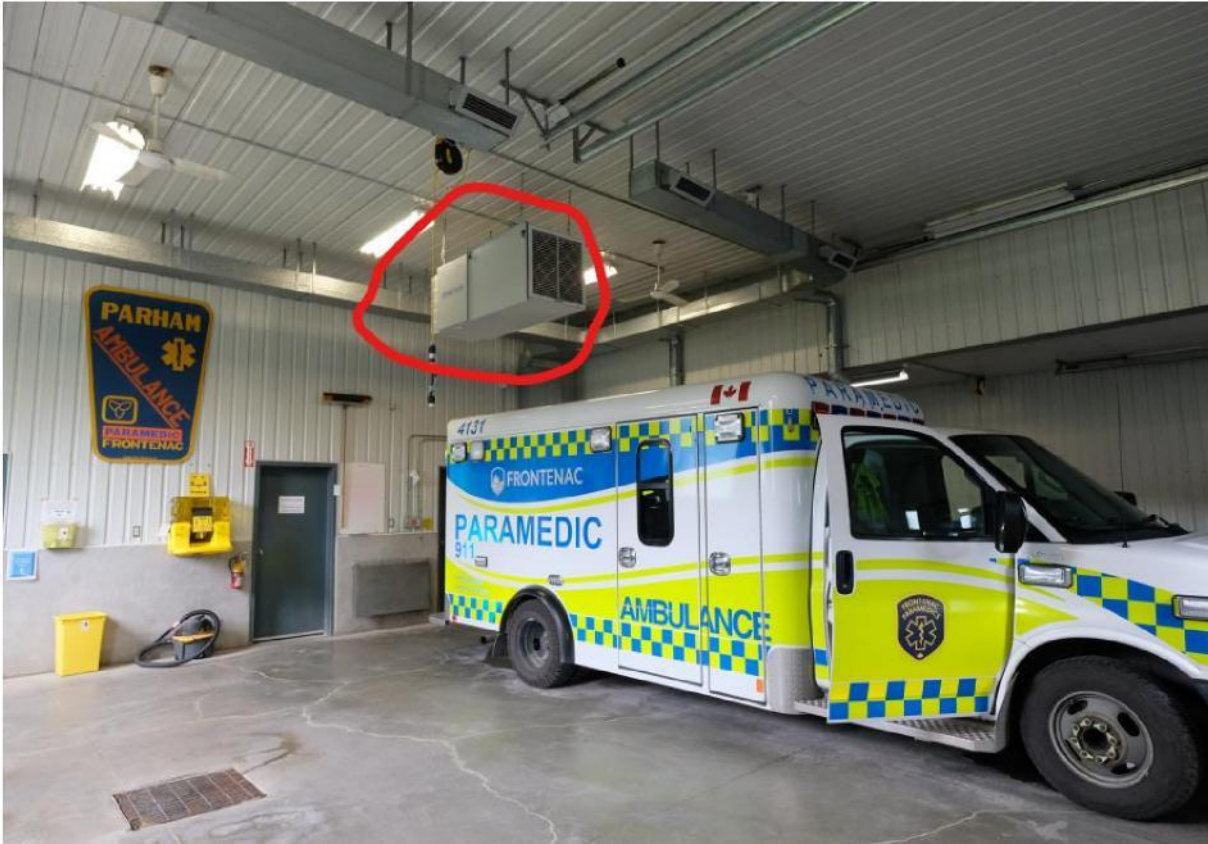
When a vehicle is started and the bay doors opened, an exhaust fan starts to purge carbon monoxide (CO). Simultaneously, a second fan in a self-contained filter unit hanging from the ceiling also starts. This fan unit is designed with filters for dust removal and serves no purpose for removal of CO. No other station has such a dust-removal system. It is recommended that this second fan be removed from the automated circuit.

Above: The ceiling-mounted fan unit does not reduce CO.

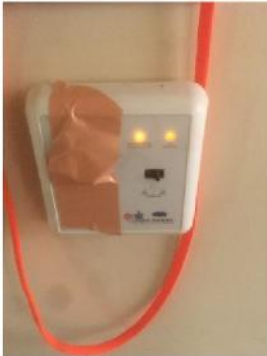
This is the control for the HRV at Palace Road. It triggers the HRV to run on high humidity. The control is taped in position and the unit is running.

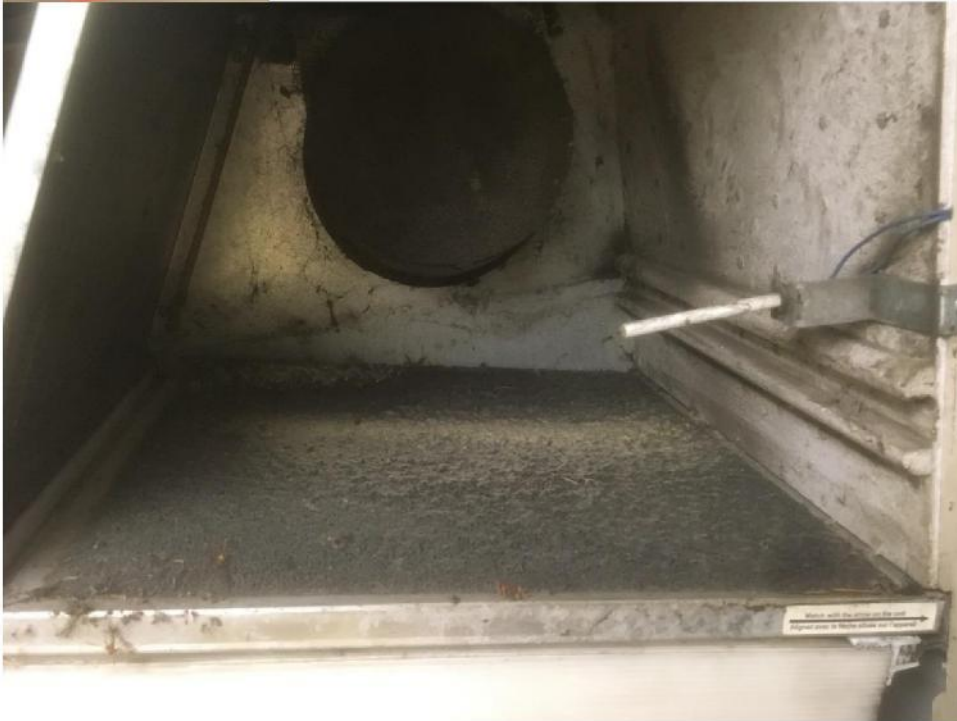
This is the inside of the HRV at Palace Road. The intake filter is heavily blocked.

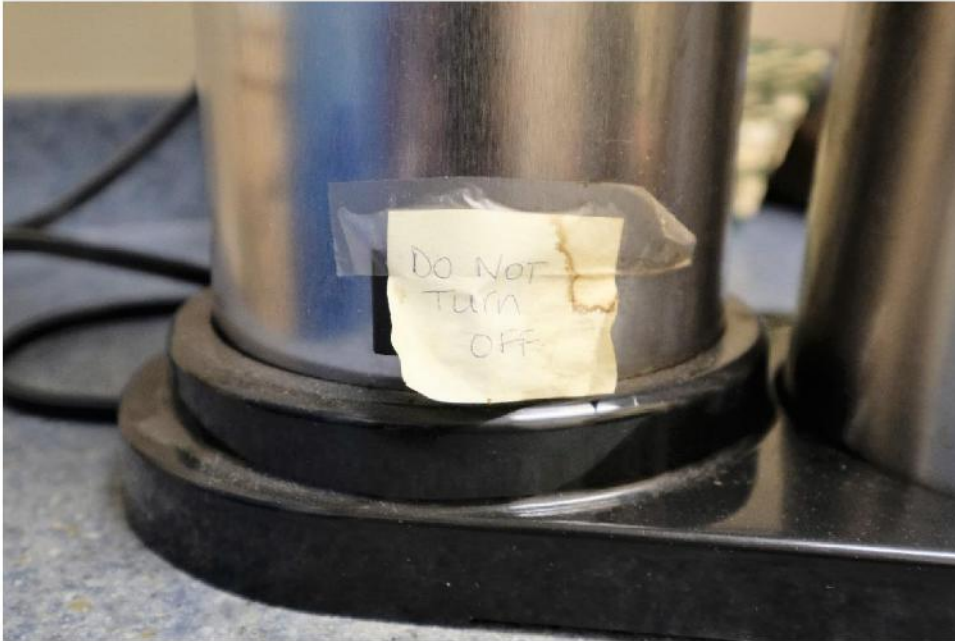
The switch on this coffee maker is taped, with a request to leave it on, presumably 24/7. The 1500W heater inside will cycle all the time, maintaining hot water in an uninsulated container. (Located main floor, Old House, Battersea Road)

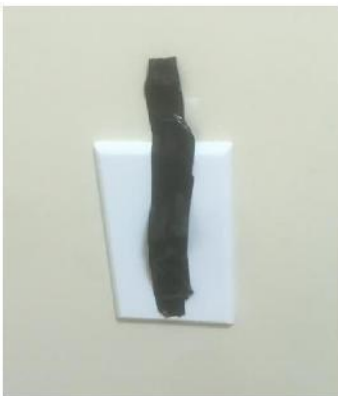
This is a light switch taped on in a washroom. Good-quality occupancy sensors, combined with delay off features, can operate washroom lights effectively. (Image taken near Fairmount boardroom)

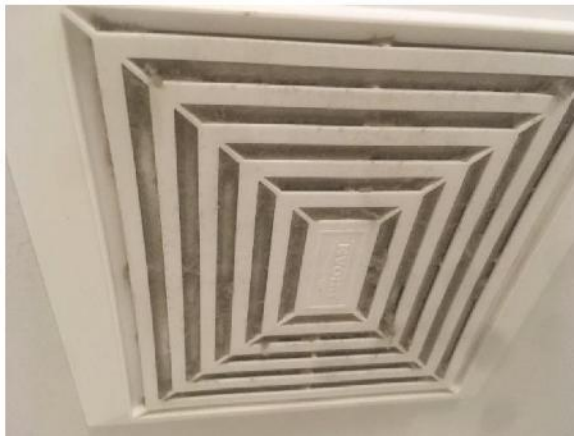
The bathroom exhaust fan was found to be running continuously and mostly plugged. It should be cleaned and put on an occupancy sensor or crank timer.

This washroom exhaust fan was found to be running continuously and is very plugged with dust. Continuous exhaust incurs costs not just for the electricity, but also for heating or cooling the air that it exhausts. Crank-style timers are an effective upgrade for small washroom exhaust fans. (Located at Parham FPS)

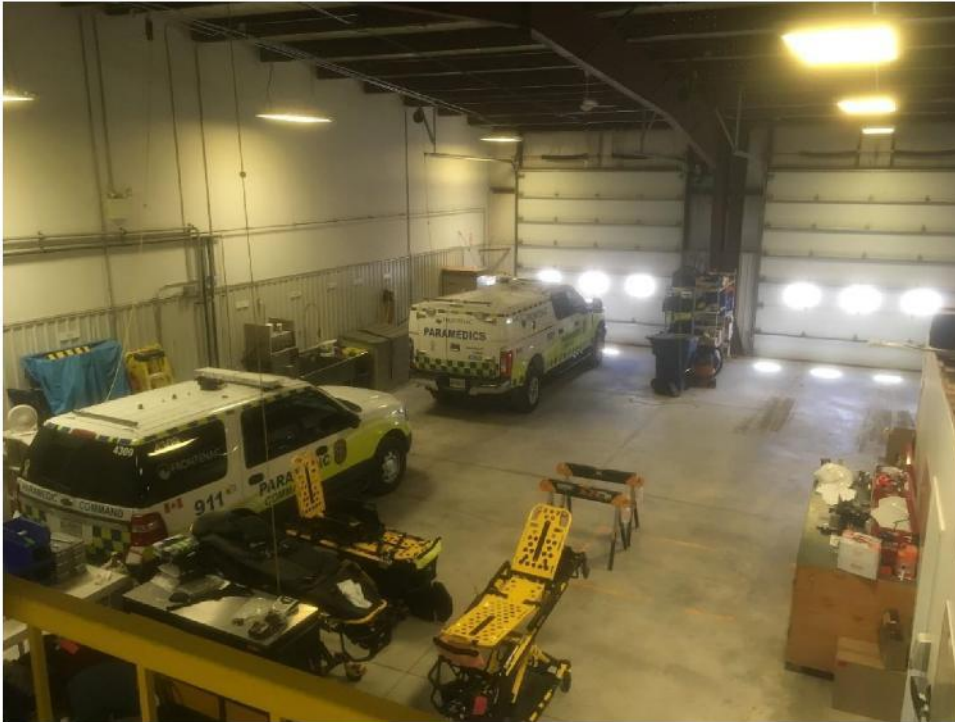
These lights were found to be left on at Fortune Cres FPS, although nobody was in the building. The lights in this area total 2100 W and costing \$0.36 per hour, or \$8.57 per 24-hour day. Good- quality occupancy sensors located in multiple places around the room could control these lights effectively.
